EVALUATION OF  
CITY OF BOSTON  
PARK AND RECREATION LAND

NEIGHBORHOOD OF NORTH DORCHESTER

Prepared for  
MAYOR'S OFFICE  
OF  
CAPITAL PLANNING

THE HALVORSON COMPANY, INC.  
LANDSCAPE ARCHITECTS AND  
SITE PLANNING CONSULTANTS  
161 MASSACHUSETTS AVENUE  
BOSTON, MASSACHUSETTS 02115

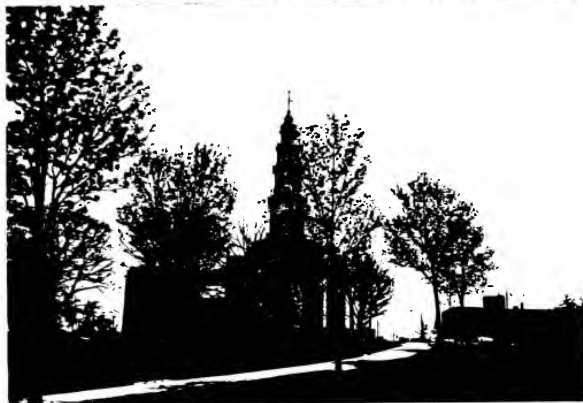
**Site Photograph 2**

View showing civil war monument and historic meeting house steeple aligned - a view not emphasized by current pedestrian circulation layout.

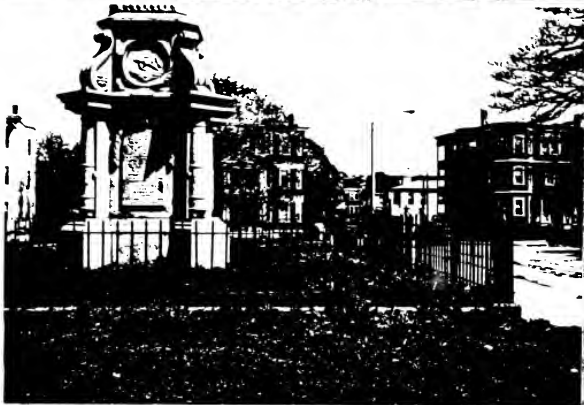
**Site Photograph 5**

Grass and weed control around monument fence could be improved.

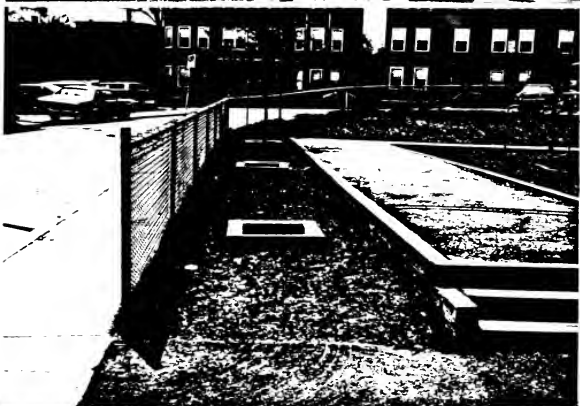
**Site Photograph 2**

Timber edge to tree  
planting creates  
difficult to maintain  
grass strip.

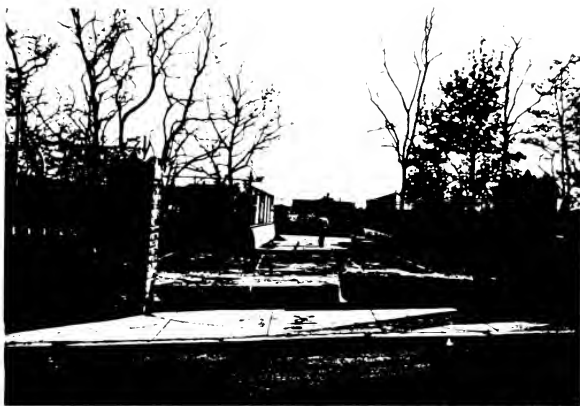
**Site Photograph 4**

Main access from  
Downer Avenue with  
view through to scenic  
overlook structure.  
Granite pieces used as  
access control.

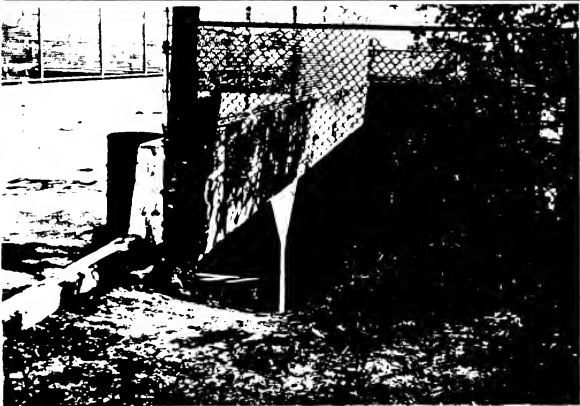
**Site Photograph 5**

Fencing missing -  
steep slope below -  
a safety problem.

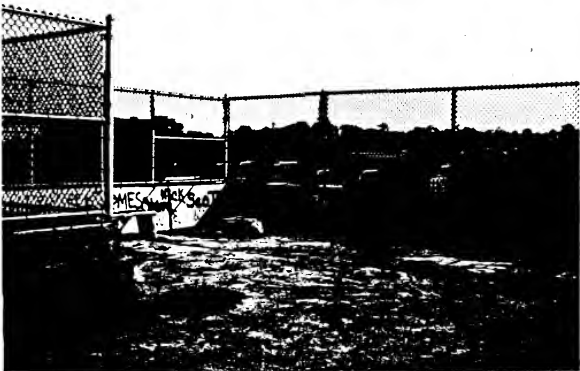
**Site Photograph 6**

Scenic overlook - a  
hidden corner. Graffiti,  
concrete spalling.

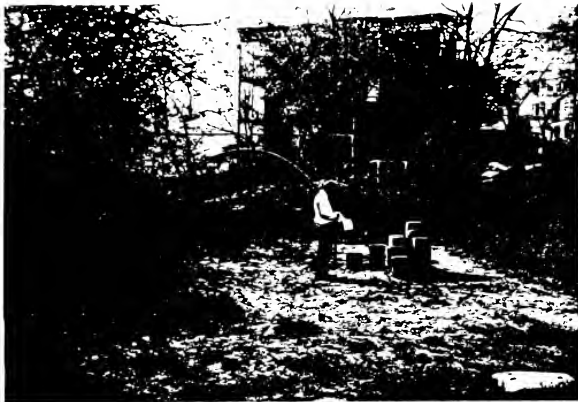
**Site Photograph 7**

Playground - safety surface encroached by grass and weeds. Equipment vandalised.

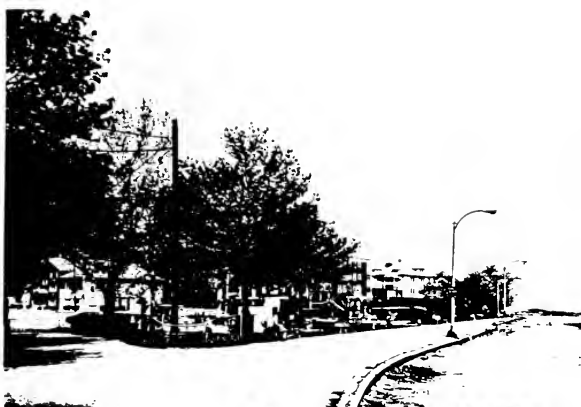
**Site Photograph 4**

View showing sidewalk along beachfront and play equipment area.

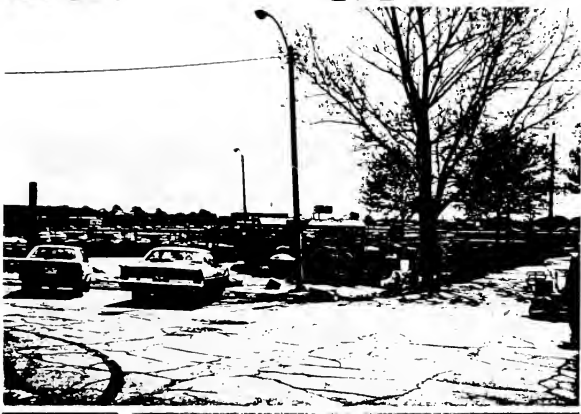
**Site Photograph 5**

Parking along edge of playground. Boulders used as access control. Note weed growth along base of fence, contributes to unkempt appearance of park.

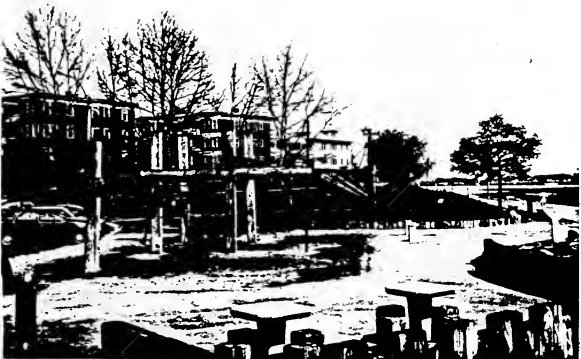
**Site Photograph 6**

Timber play structures - poor safety surface. Many broken or missing parts make structures almost unusable.

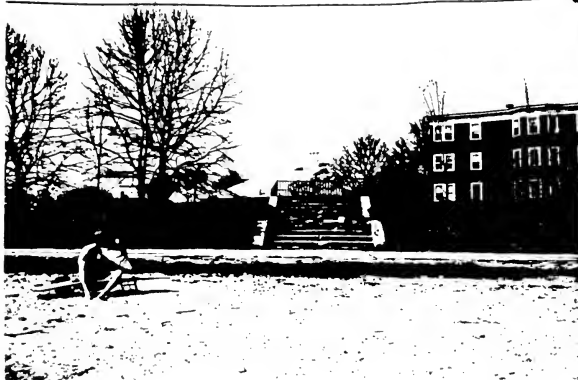
### Site Photograph 8

Poor grass growth - note broken glass. Need for access control on right along parking edge.

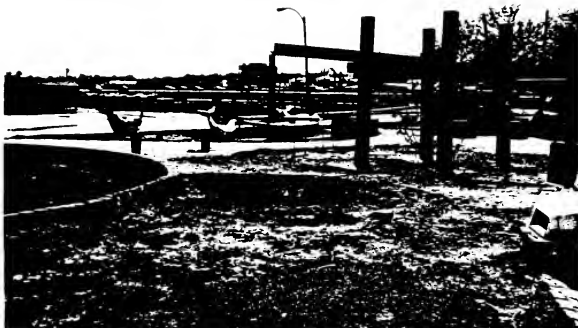
### Site Photograph 9

Pedestrian access from Denny Street. Trees growing well in grassed area.

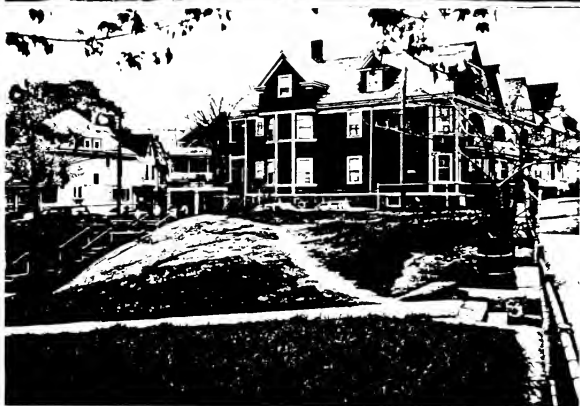
**Site Photograph 6**

Desire line showing corner of site used as short cut.

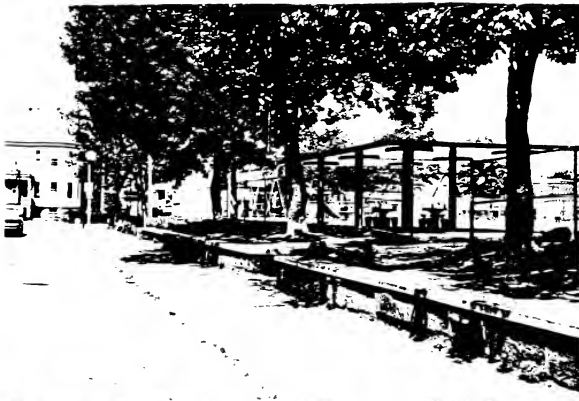
**Site Photograph 1**

View of edge along Harbor View Street. Trees growing well in continuous plant bed along edge. Grass worn and poorly maintained. Trash needs pick up.

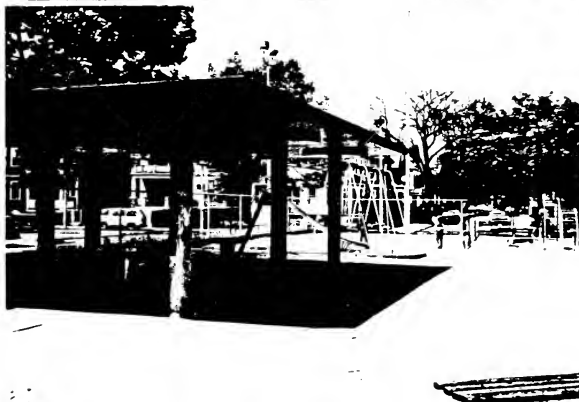
**Site Photograph 2**

Shelter with game tables. Play equipment behind.

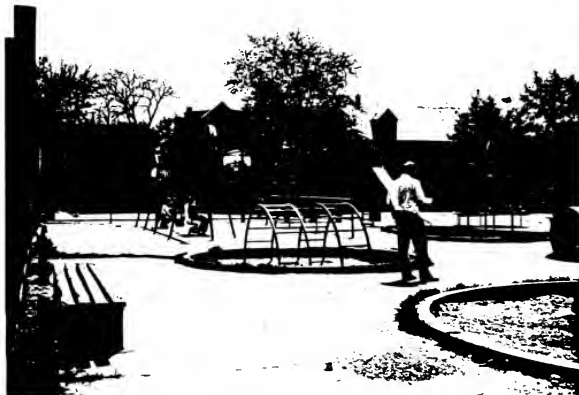
**Site Photograph 3**

Play structures in good condition but sand level low and concrete footings exposed. Weeds need removal.

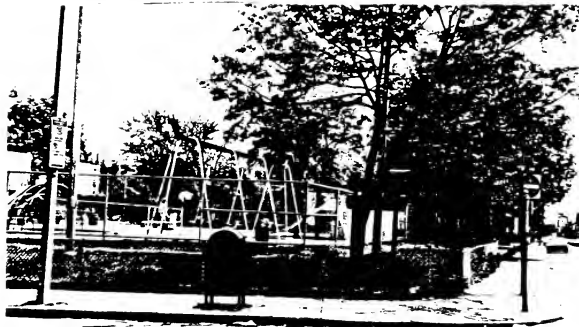
**Site Photograph 4**

View of corner of  
 Dorchester and Harbor  
 View. Mature trees  
 define edge. Sign  
 gives park identity,  
 welcomes. Are two rows  
 of fencing around park  
 necessary?

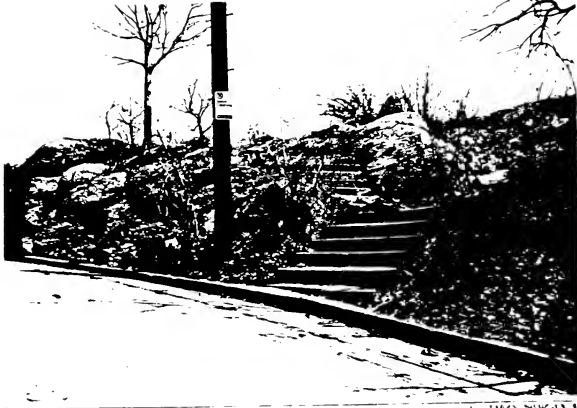
**Site Photograph 1**

Stone step access from  
Caspian Way.

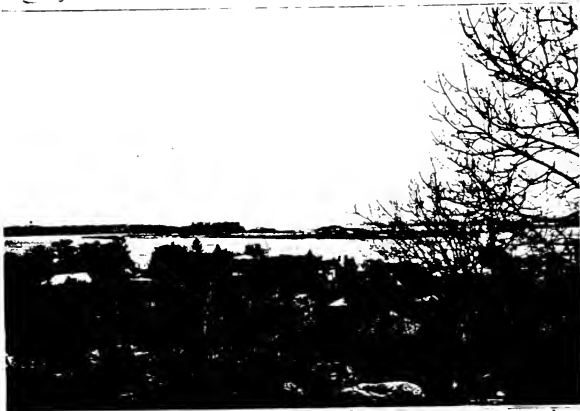
**Site Photograph 2**

Panoramic view from  
high point of park  
showing Neponset Bay.

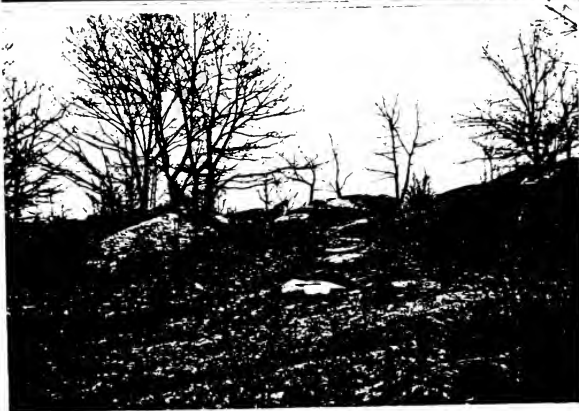
**Site Photograph 3**

Typical character of  
terrain in center of  
park. Wheels of dirt  
bikes eroding surface.

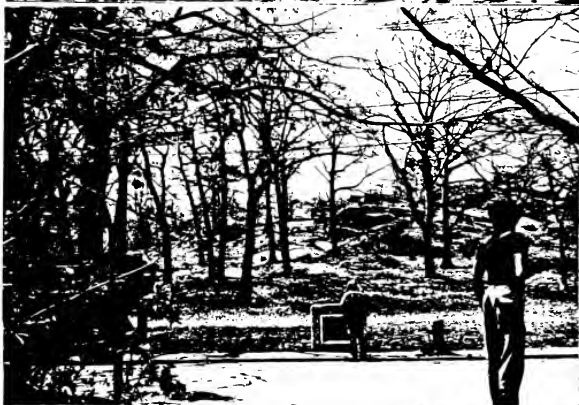
**Site Photograph 5**

View into site showing rock outcrops and mature trees as outstanding scenic features.

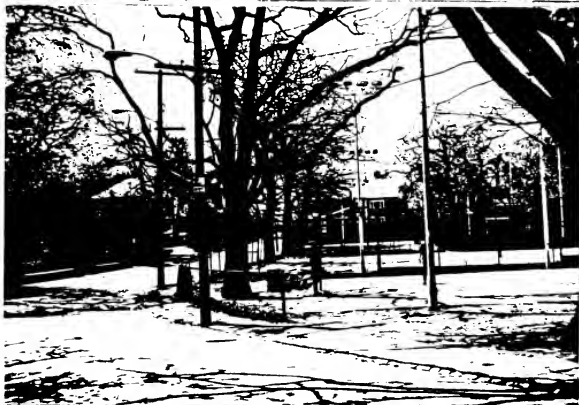
**Site Photograph 6**

Basketball court and tennis court located on level area at edge of park. Mature shade trees define edge and provide shade.

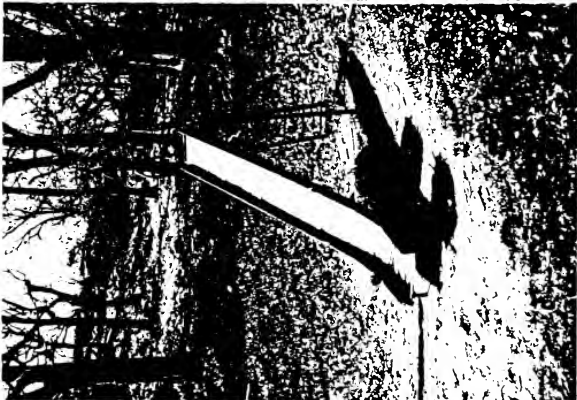
**Site Photograph 12**

Slide - exposed concrete footing and loose metal at left end of slide both safety hazards.

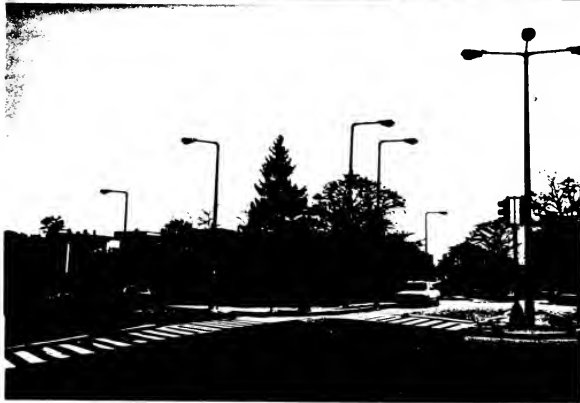
**Site Photograph 3**

Benches located near bus stop. Grass on this corner worn away.

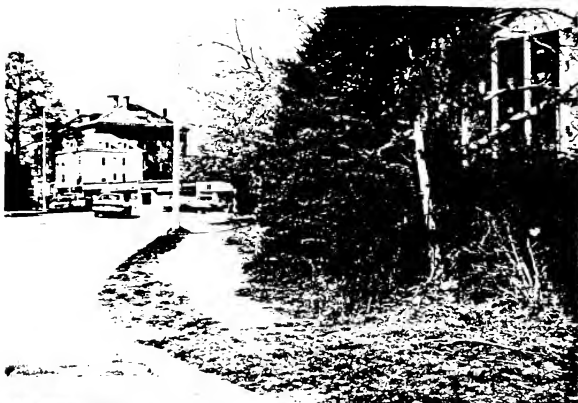
**Site Photograph 4**

Pedestrian circulation has worn grass along Bowdoin Street. Sidewalk needed.

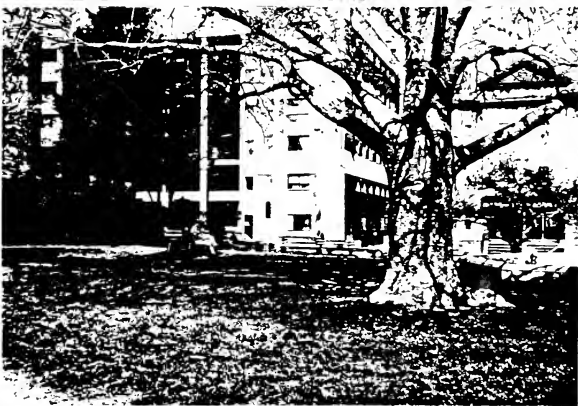
**Site Photograph 5**

Mature Beech tree contributes to this square. Tree is being inappropriately used for a rope swing. Bare grass patches at base of benches.
